Motorola Repair Report

Job No: 3902411

Product: MC7094-PKCDJQHA7WW
Serial Number: 6128520801880
Customer Info: Bjorn Waite
Book In Date: 9/21/2009
Ship Date: 9/25/2009
Problem: Damaged by shotgun blast
Repair Request: Back up data from device if possible. Diagnose damage and repair if possible. Do not replace the outer casing. Leave data.

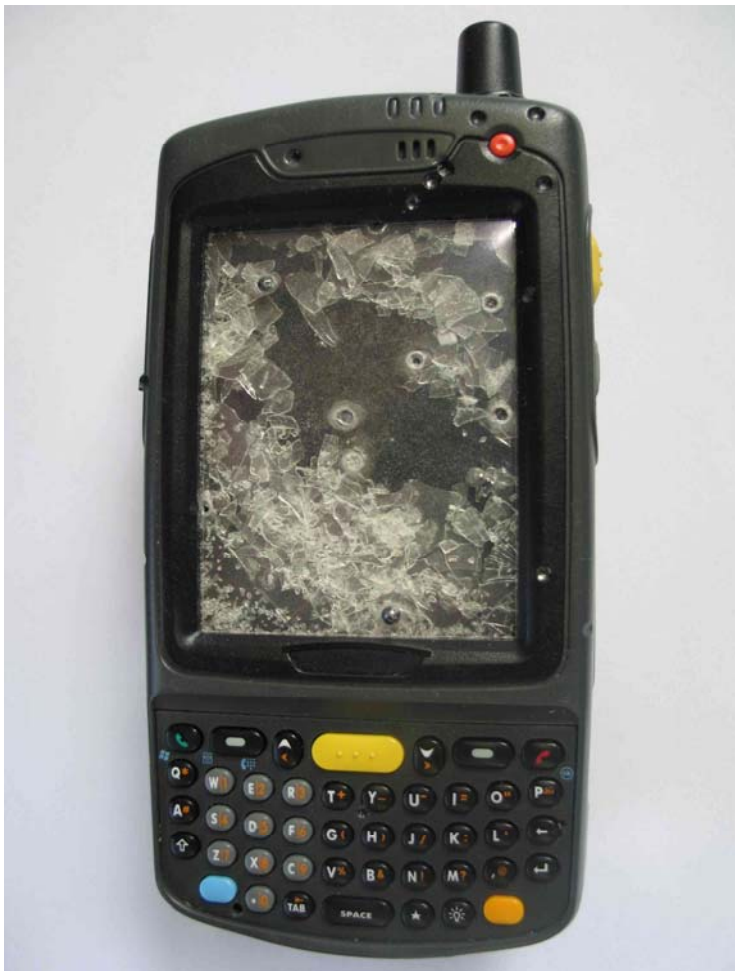
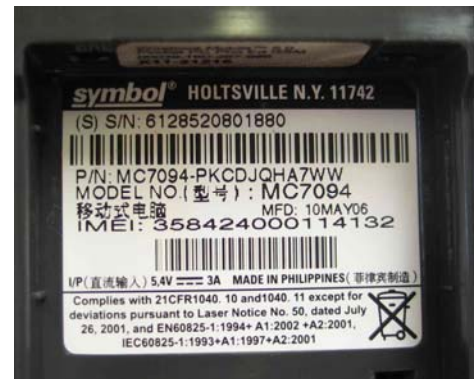
Some marks on outer front case, on antenna cover and keys where it was hit by shot. The marks are superficial as the outer case was not penetrated or split by the shot (Figure 1).

Figure 1 - Physically damaged unit and its manufacturing label details

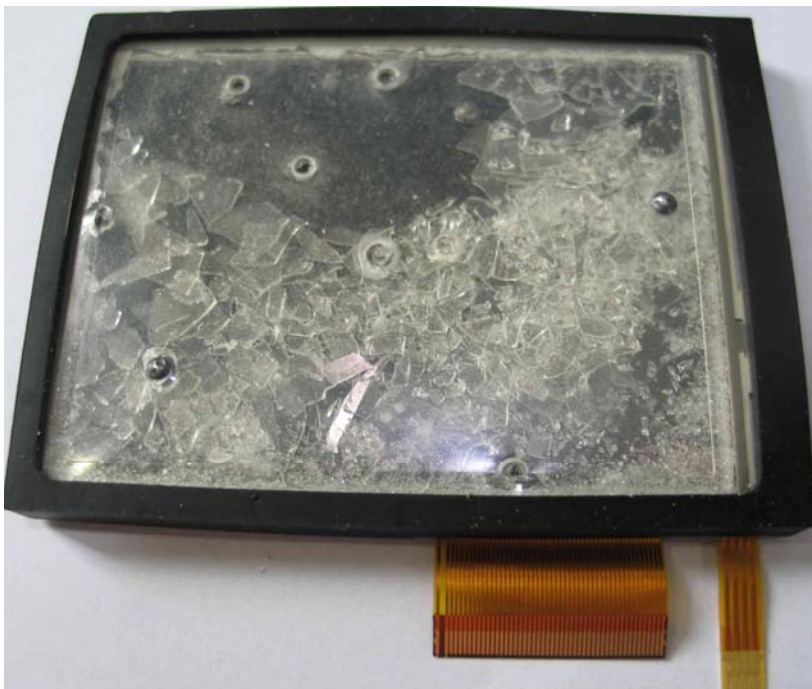
Outer touch panel shows some punched or partially punched holes, where it was hit by shot. Inner glass plate of the touch panel scattered. Display itself remained a whole with several marks on outer polarizing foil where it was hit by shot. There was a glass dust on a rubber gasket. Crushed glass did not get into the unit. (Figure 2, 3 and 4) .

Figure 2 – Close-up view on the display assembly in a rubber gasket

Work performed: Device front case removed, cleaned out the glass, shot and dust of broken inner touch panel. Replaced with a new display assembly. Replaced dirty rubber gasket. Performed functional test and check of the backup battery. Main battery charged and device packed for return.

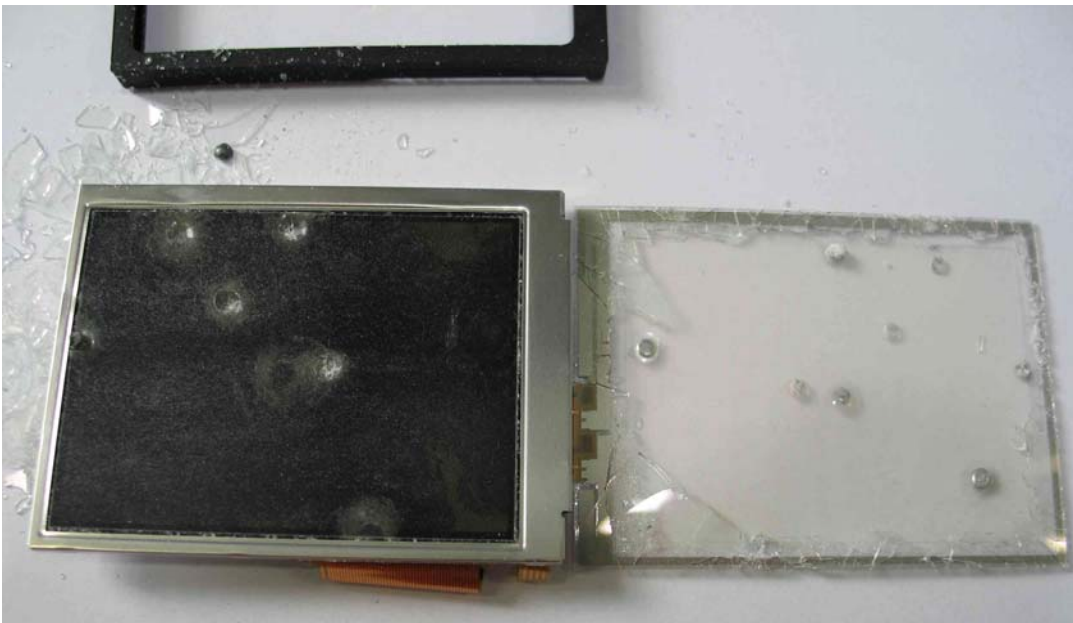
Figure 3 – Close-up view on the display, touch panel and rubber gasket

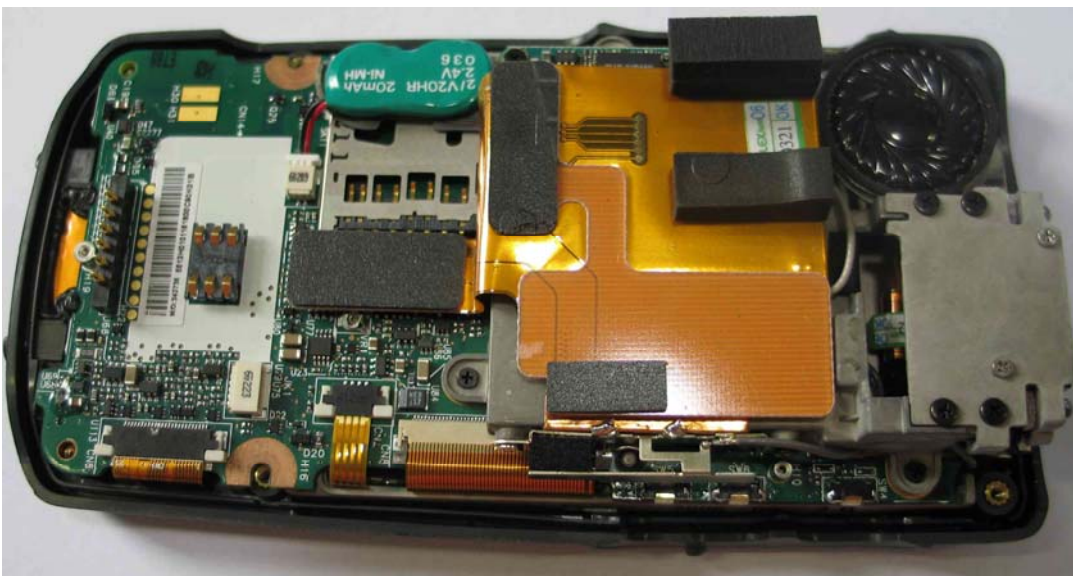
Figure 4 – Inside view showing no penetration of glass dust

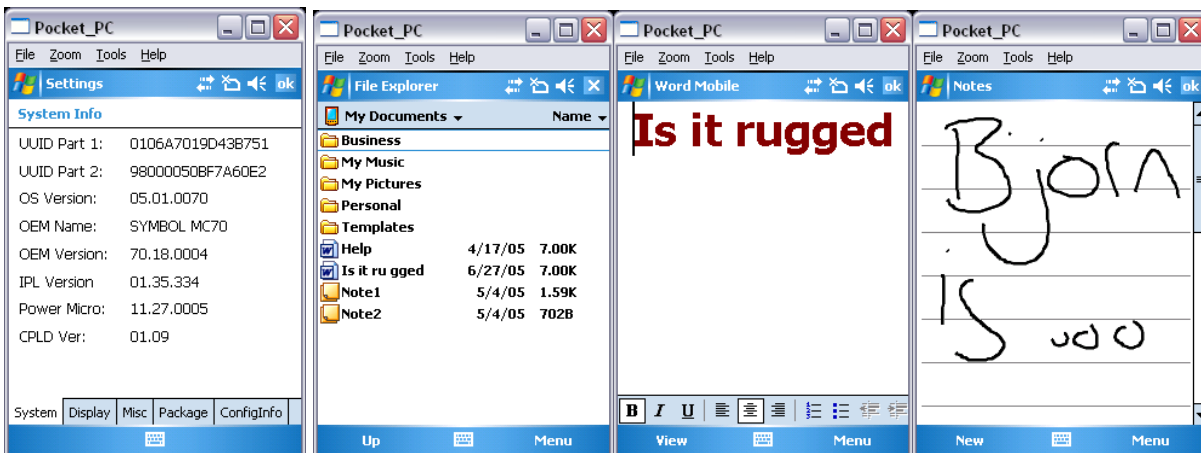
No other internal or external damage found. Unit connected to a PC through ActiveSync and operated by „remote desktop“ application. All data in device memory intact (Figure 5).

Figure 5 – Screen shots (product info, directory, content of two files) with intact data
